December 2008  
Fuji Electric Systems Co., Ltd.  
Controller Div.  
Automation & Solution Business  
Headquarters

## **MICREX-SX Series** **Notice of Functional Expansion of Board Controller** **(SPB Version)**

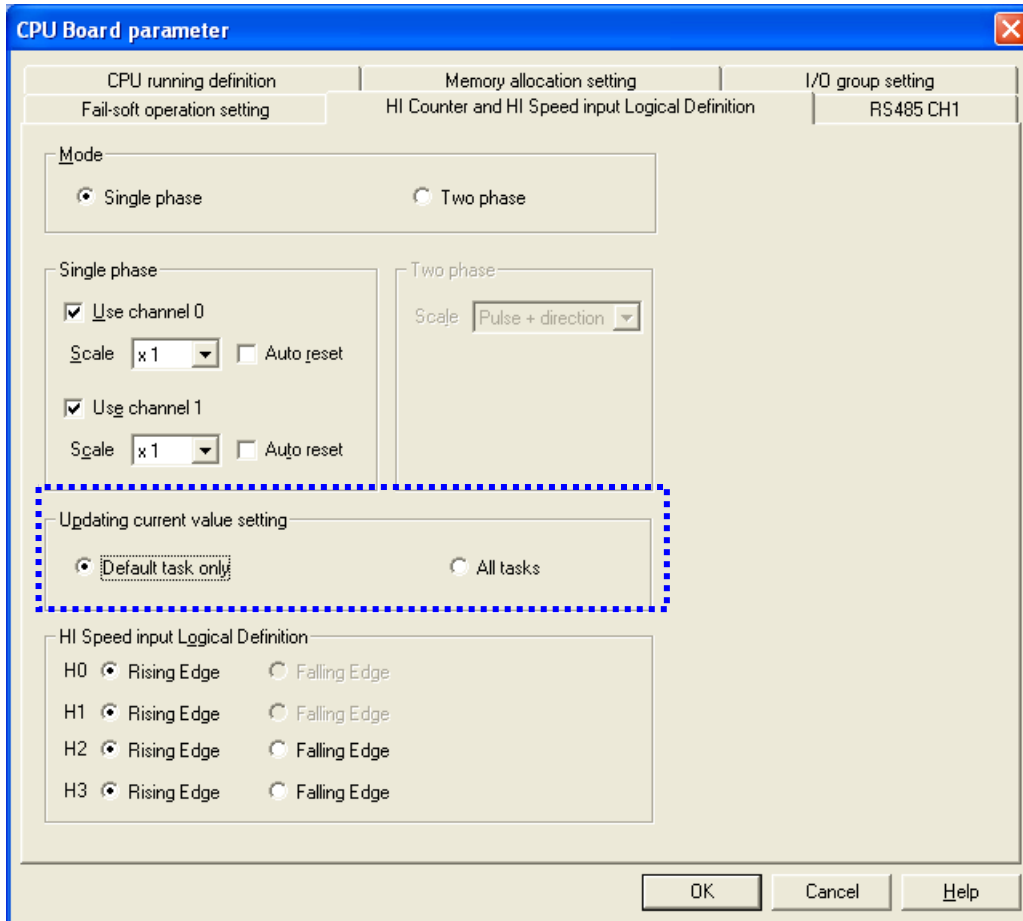
With the new version, it is possible to update the current value of a high-speed counter in synchronization with a scheduled task or event task.

Conventionally, the current value of a high-speed counter was updated in synchronization with the execution of the default tasks, which involved a maximum execution time delay equivalent to the execution cycle of the default tasks.

With this expansion, the current value can be updated in synchronization with the execution of an individual task. Therefore, the execution time delay of the current value read in each task will be limited to a maximum period of the task execution time.

The updating of current value setting is by default set to *Default task only* to maintain compatibility with the previous version of the Board Controller.
